Re: Approximate Original Contour Determination, Plateau Mining Corporation, Willow Creek Mine, [REDACTED]

Willow Creek
Approximate Original Contours
C007038
Technical Analysis
November 1, 2000

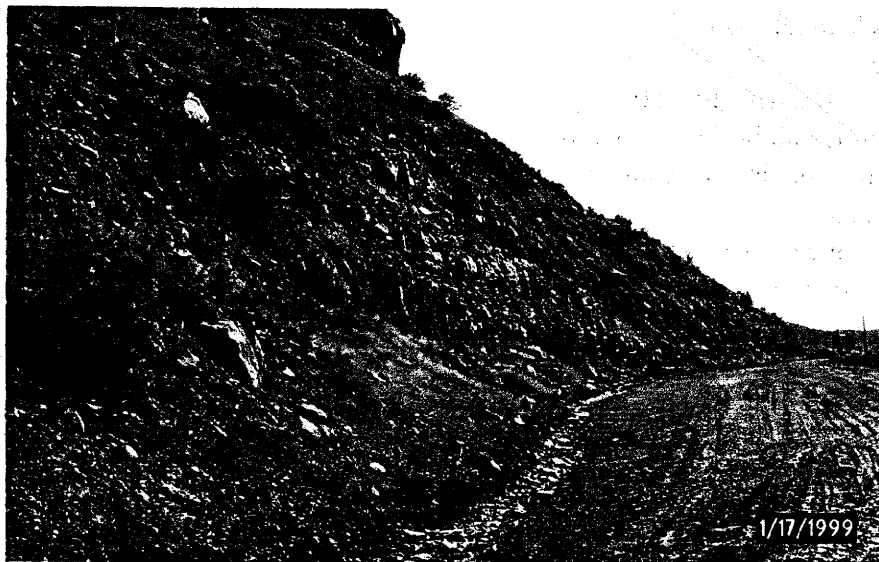
The main requirement for cut slope retention is that the slopes are geotechnically stable. Figures 1 and 2 show the road cut was made in bedrock. The Division considers cut slopes in bedrock to be stable unless shown otherwise. The cut slope has existed for 23 years and there is no sign of instability.

Figure 2 shows the cut slope for the access road. The cut slope was made in bedrock, which will remain stable in the present configuration.
